painting contractor newsletter

A Root Cause of Premature Paint Failure – Surface Preparation

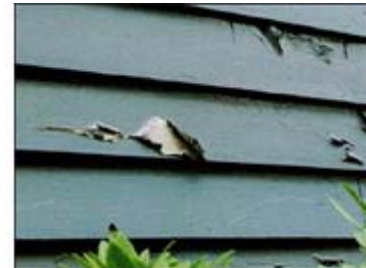
As an example, let's consider peeling of an exterior paint as shown in this picture. The failure is clearly due to loss of adhesion.

Even with top quality exterior paint, one can see failure such as depicted right, when short-cuts are used in securing proper surface preparation. Specifically, the picture shows loss of adhesion – this premature failure can be due to several factors, including dirt, moisture, or loose and flaking paint; or wrong selection of paint. Making sure the surface is properly prepared will give your paint a firm surface on which to bond.
